# Manhole Inspection Summary

Manhole # S27Q\_\_004MH

**Location** Address: **1315 Bayard ST**

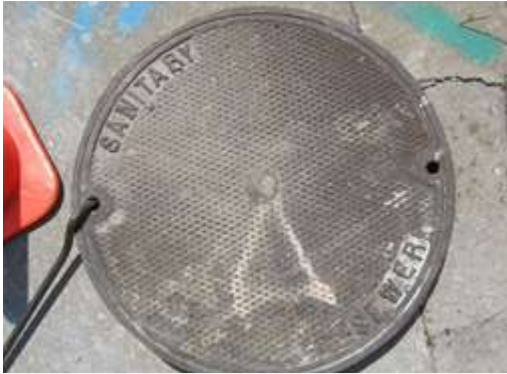
Cover View

**Cover** Shape: **Circular** Diameter: **32** (in.) Length: **0** (in.) Dist A/B Grade: **1.5** (in.)

Type: **Sanitary** Condition: **Sound** Cover Material: **Cast Iron**
